ROAD SAFETY AUDIT OF MUMBAI METRO RAIL CORRIDOR

JULY 2013

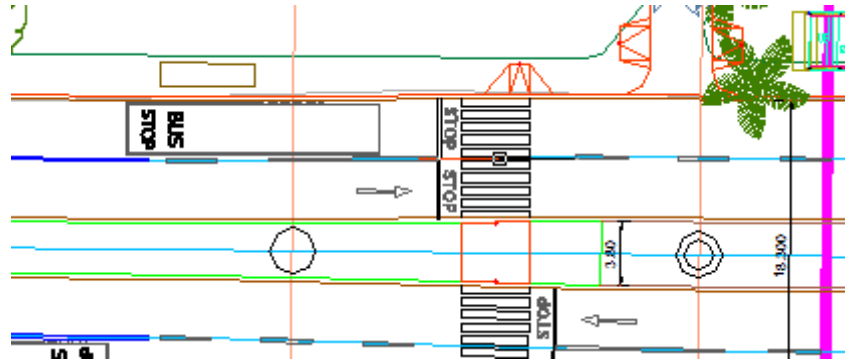
At some instances bus stops are placed just before a pedestrian crossing. This reduces the visibility of pedestrians from vehicles passing the bus stop.

Figure 2: Bus stop before pedestrian crossing

Bus stops should be placed after pedestrian crossings.

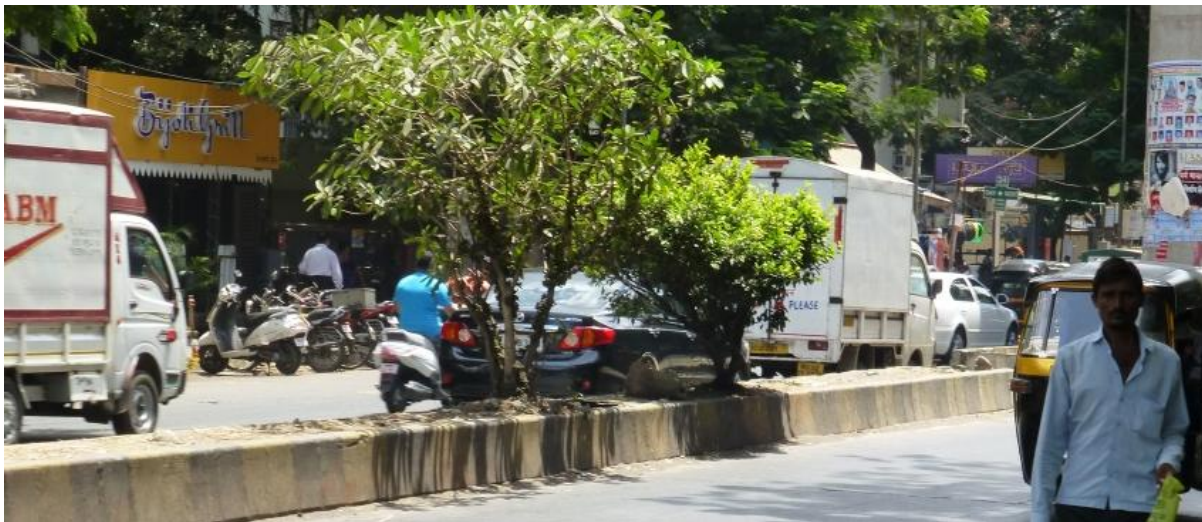
The introduction of the Metro line implies many changes in the use of the road. One of the major changes is that provisions for parking are greatly reduced. The demand for parking, however, is high and illegal parking for example along the central reserve was observed. Parked vehicles obstruct visibility and increase hazards especially for crossing pedestrians.

Figure 3: Vehicles parked at central reserve

A survey on demand for parking should be undertaken and possibilities for satisfying a reasonable amount of this demand should be provided as dedicated (marked) parking along the corridor or on adjacent streets.

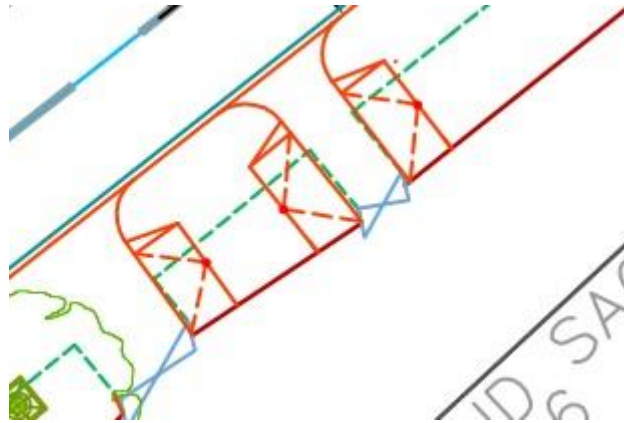
At accesses to properties the sidewalk is cut off so that the access is at street level. This means that accesses work as side roads and vehicles can turn at some speed. Also, the sidewalk is often interrupted and does not provide safe passage for pedestrians.

Figure 4: Changes in sidewalk level due to gates close to each other

The sidewalk should be kept at the same level between side roads along the corridor, prioritizing pedestrians. A raised sidewalk will reduce the speed of turning vehicles. Where this recommendation cannot be followed accesses should be reconsidered to ensure sufficient visibility, width of and access to ramps.

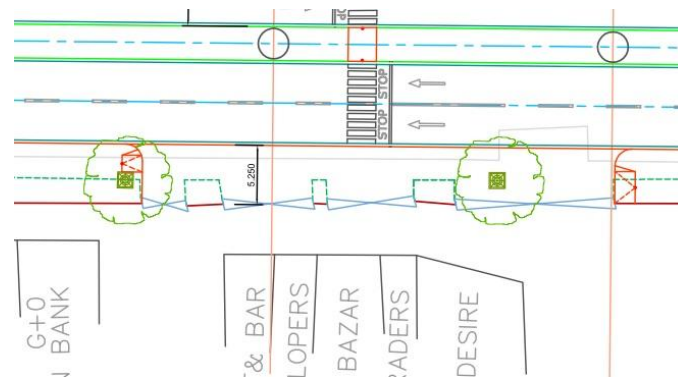
Figure 5: Sidewalk at street level over a longer distance

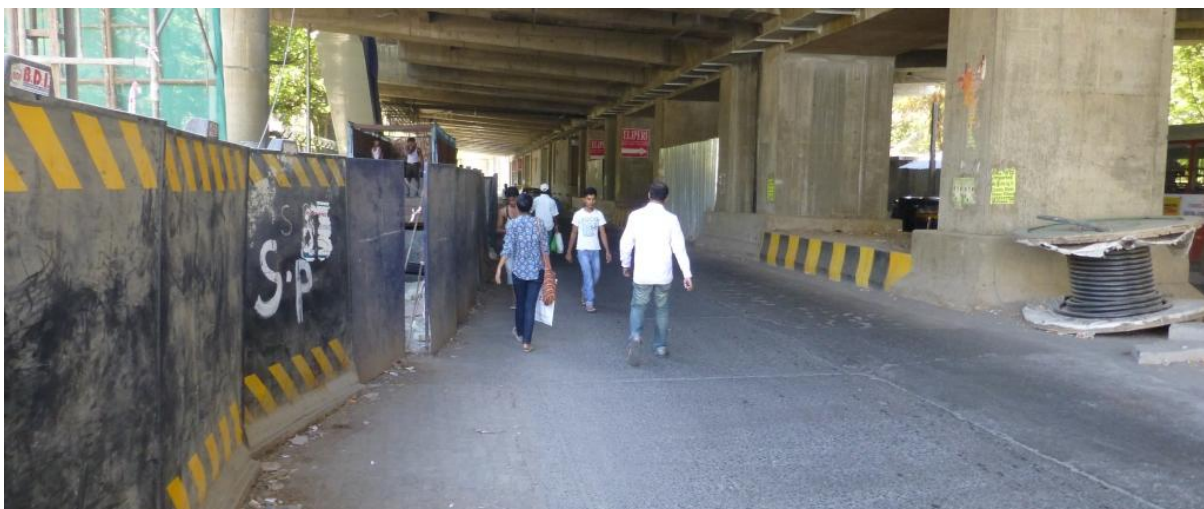
A construction site along a busy road induces risks for both road workers and road users. The construction sites at the metro corridor are not marked and no guidance or protection is provided for any road users. This is especially a problem for pedestrians passing under the coming stations. They have to walk in the vehicle lanes and the forward visibility is very poor.

Figure 6: During construction pedestrians are forced out in the vehicle lanes

National standards for safe management of construction sites should be in place and followed at any construction site.

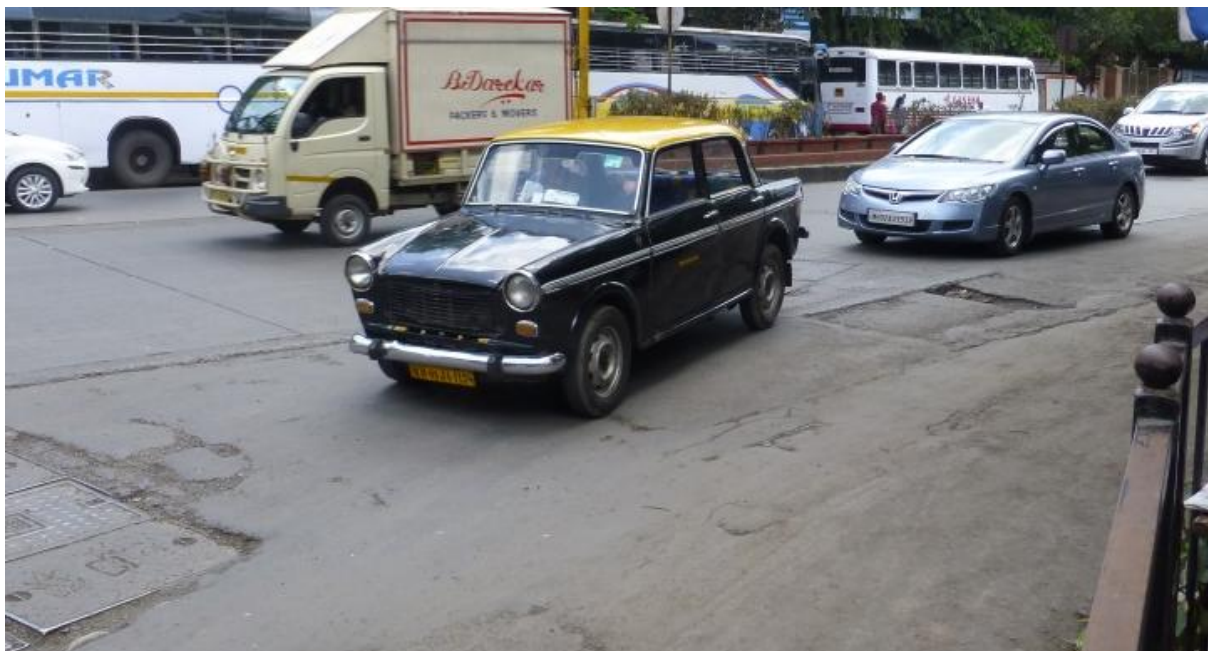
It was often observed that the pavement was in a poor state of maintenance. This poses a risk especially for two-wheelers.

Figure 7: Pavement in poor condition

It is assumed that the corridor will be given a new overlay after construction works finish, but if that is not the case repairs should be undertaken where conditions pose a risk to the road users.

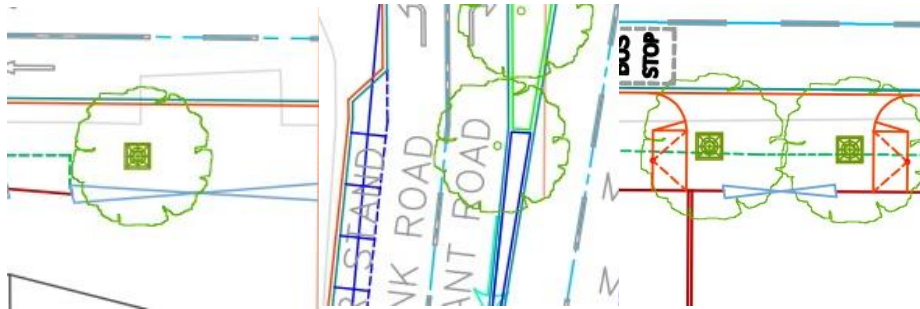
It was noticed that some trees shown in the project are not in appropriate places. Some of them are in front of ramps, property gates or even in the middle of the street. It was not clear if they are going to be removed or if they are going to be kept in the project.

Figure 8: Trees in front of a gate, in the middle of the street and in front of the ramps

The trees should not be an obstacle to pedestrians or other road users. If the project includes the trees, the infrastructure around them should be planned and built in a way that will not be obstructed by the trees. Otherwise, they should be removed.

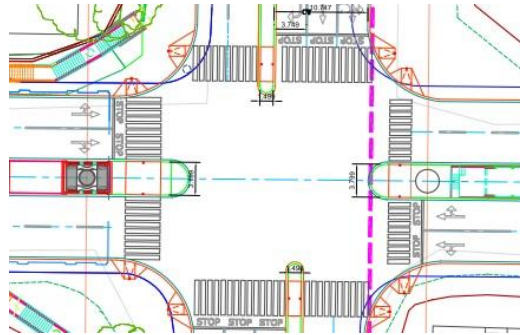
At some intersections or near the property gates, the turning radius is too wide. This should be avoided, as vehicles are likely to use higher speeds to turn instead of decelerating, which would be the safer way to turn.

Figure 9: Intersection with large turning radii

To ensure that vehicles make the turning movements at lower speeds, the turning radius should be as small as possible. This can be done through the widening of sidewalks and extension of the central medians.

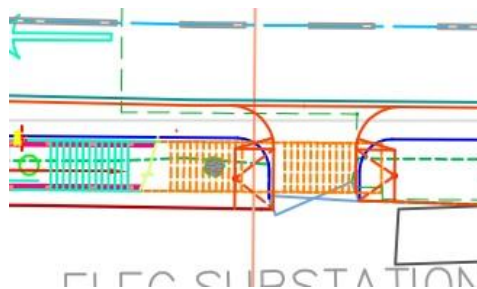
Under some stairs on the stations there are property gates. Vehicles leaving the gates may not have appropriate visibility of the street and oncoming vehicles and pedestrians due to these stairs, and they may also not be seen by the main road users.

Figure 10: Property gate under the station's stairs

The property gates under the stairs should be properly signalled, to alert drivers on the street about the vehicles leaving the gate. The approach should also allow drivers leaving the gate to have an appropriate visibility of the main road and pedestrians crossing the area in front of the gates.

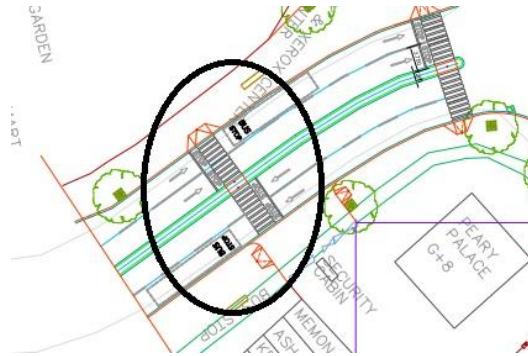
Location: J.P. Road, in front of Peary Palace

The pedestrian crossing in front of Peary Palace is aligned to a property gate. It may create conflicts between pedestrians and vehicles arriving or leaving the property.

Figure 11: Pedestrian crossing aligned to a property gate

The pedestrian crossing should be moved in order to lead pedestrians to safe sidewalks. The bus stops should be kept close to the crossings.

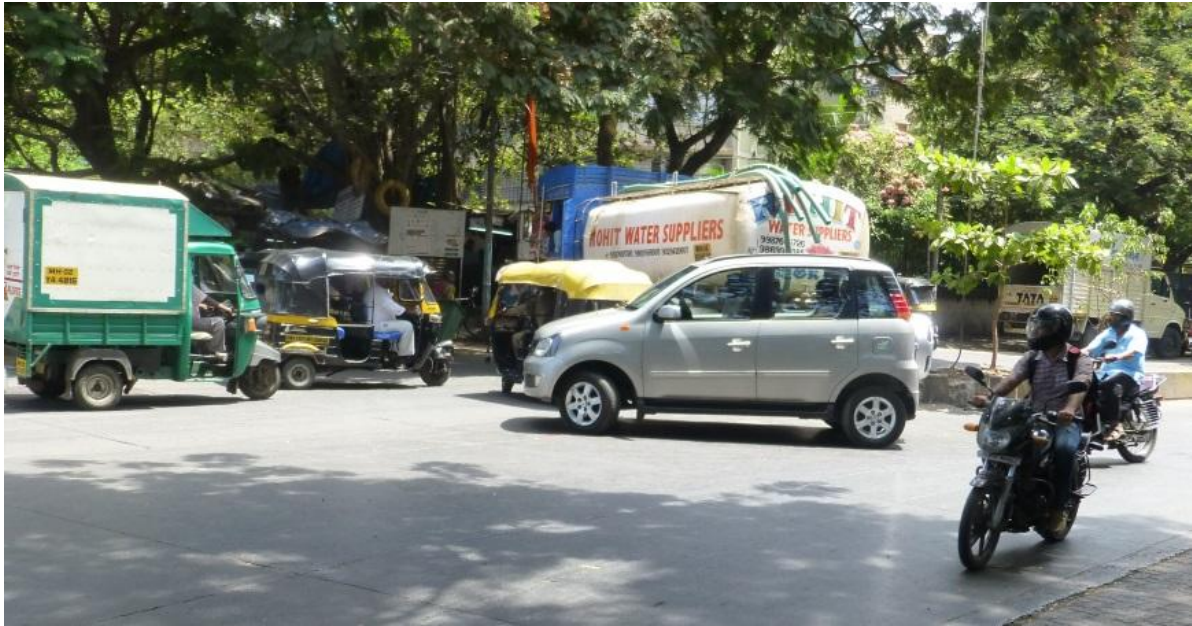
The junction is very skew and not signal-controlled. Vehicles from Panth Road drive against traffic to go south on J.P.Road. Many drivers also make a U-turn from J.P.Road to Panth Road but space is not sufficient for large vehicles.

Figure 12: Trucks cannot make U-turn into Panth Rd.

It should be considered to change the junction to a roundabout. The layout should be as tight as possible to avoid vehicles moving in opposite direction in the roundabout. Overrun areas (for example a circle of cobblestone) can be placed at the perimeter of the central circle.

Even with a narrow roundabout some vehicles may still go from Panth Rd. against traffic. If possible Panth Rd. should be changed to one-way away from J.P.Road.

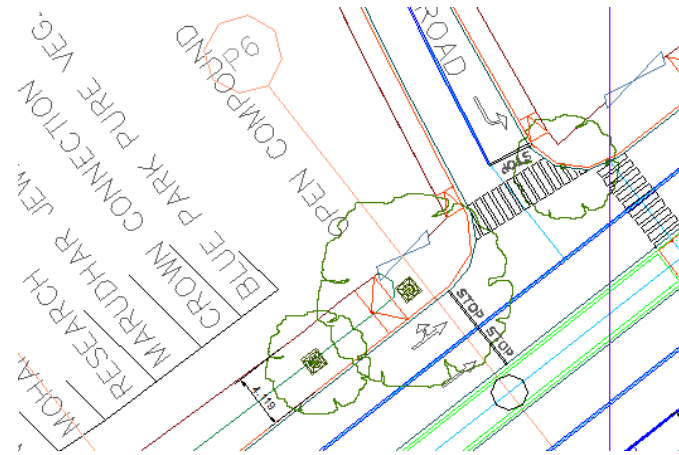
Location: J.P. Road with Vasvani Road

There is a property gate at J.P. Road, close to the intersection with Vasvani Road. It may create conflicts between vehicles using the main road and vehicles leaving the property. Two trees on the sidewalk blocks visibility.

Figure 13: Property gate too close to the intersection and near trees

This property gate should be moved to the side road or to a place further from the intersection.

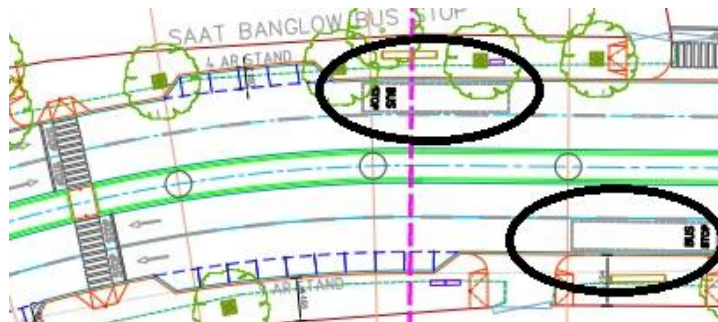
Location: J.P. Road, P12

Near the bus stops in front of Shopping Center there are no pedestrian crossings installed. It means that passengers will be tempted to cross the main road far from the crossings, without any protection. This problem gets even worse as the shopping is likely to attract more people to this area.

Figure 14: Bus stops far from the pedestrian crossing

Bus stops should be moved closer to the regulated pedestrian crossings and guardrails should be installed to guide pedestrians to the safe crossing points.

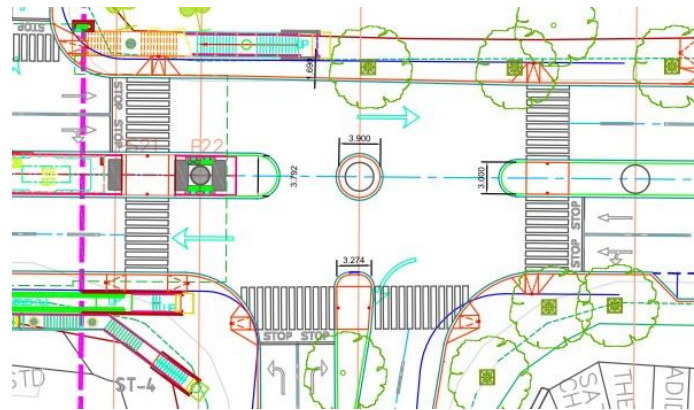
Location: J.P. Road, P22

The geometry of the junction is complicated because of the column in the middle. Right-turning vehicles were seen passing on either side of the column from both directions. U-turns are also performed from all directions.

Figure 15: Intersection of J.P. Road and Balasaheb Sawant Road

It is recommended to close the central reserve at this point.

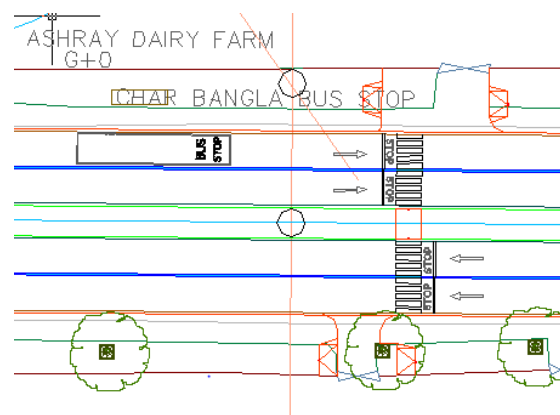
Location: J.P. Road, P37

The bus stop at this location is placed before the pedestrian crossing which may reduce visibility.

The pedestrian crossing ends at street level on the northern side. If the recommendation of using raised crossings at mid-block pedestrian crossings is followed the crossing should have a ramp. This would complicate the passage of vehicles for the property gate.

Figure 16: Bus stop in front of pedestrian crossing

To keep consistency along the project, the bus stop and the pedestrian crossing should shift place. This would allow vehicles to have a better visibility of pedestrians crossing the main road. This would also solve the access problem.

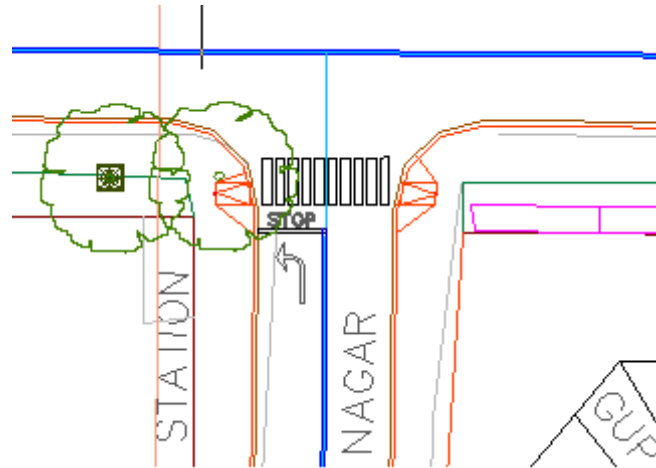
Location: J.P. Road, P41

The ramps at the pedestrian crossing in the side road seem to be very narrow.

Figure 17: Narrow ramps at pedestrian crossing

Check that the width of the ramps is in accordance with Indian standards.

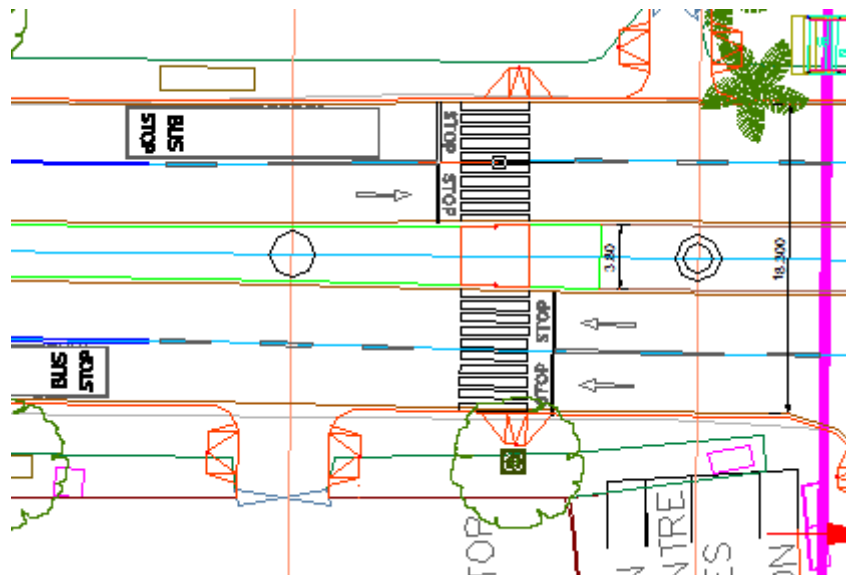
Location: J.P. Road, P48

The ramp at the southern end of the pedestrian crossing ends in a tree trunk.

Figure 18: Ramp ends in tree

Move the ramp to other side of pedestrian crossing.

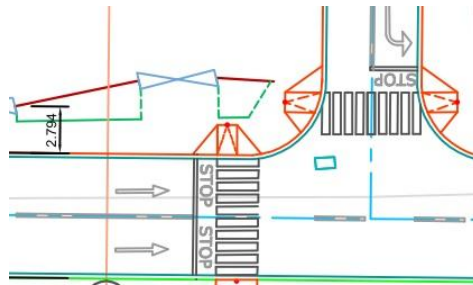
Location: J.P. Road, P63

At the intersection of J.P. Road and Bazar Road an arrow in the left lane indicates that the vehicles are only allowed to move straight. Apparently, this lane should allow access to Bazar Road as well.

Figure 19: Lane markings indicating straight movements only

If left turning movements are allowed at this point, which would not present any safety problems, this arrow should also indicate this movement as a possibility to vehicles approaching to the intersection.

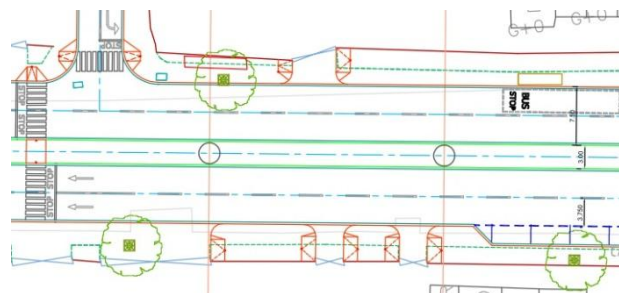
Location: J.P. Road, P65

There is a bus stop placed at this point, but there are no pedestrian crossings near it. This is a problem, as bus passengers don't have safe conditions to cross the main road after alighting or when attempting to access the bus stop.

Figure 20: Bus stop far from pedestrian crossing

To allow passengers to cross the main road safely, bus stops should always be installed near pedestrian crossings.

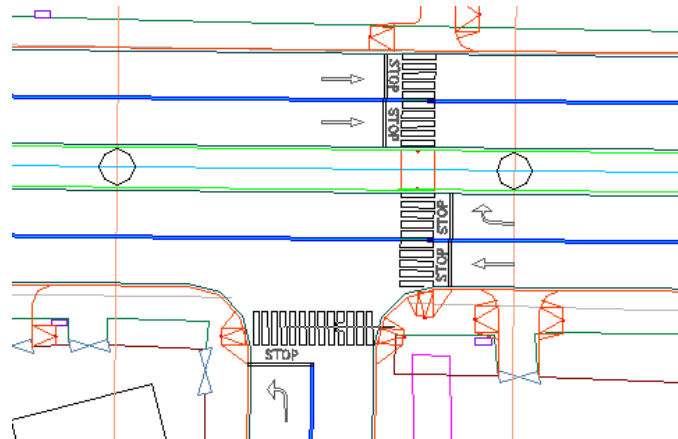
Location: J.P. Road, P69

Markings on the southern half of J.P.Road indicate a right turn lane and a lane for going straight. The central reserve does not allow right turn and the side road seems to be bidirectional allowing for left turns.

Figure 21: Marked turning movements

Replace the markings with a straight arrow in the right lane and a combined straight/left arrow in the left lane.

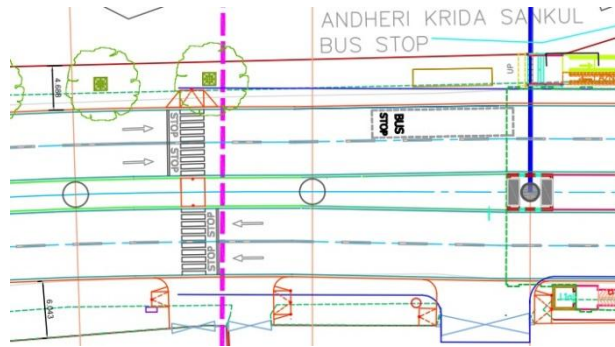
Location: J.P. Road, between P79 and P80

In front of a property gate, there is a pedestrian crossing (see *Pedestrian crossings in front of a property gate*). This crossing is also far from the bus stop and the stairs of the metro station.

Figure 22: Pedestrian crossing in front of property gate

The location of the pedestrian crossing should be carefully designed. The crossing should be placed as close as possible to the bus stop and the stairs of the metro station, taking into consideration that pillars may obstruct the visibility of pedestrians waiting to cross. Guardrails should be placed to help guide pedestrians to the crossing.

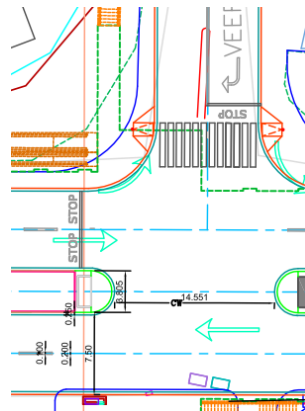
Location: Veera Desai Road

The arrow drawn in one of the lanes of Veera Desai Road indicates that it is allowed to turn right to access the main road, which may create many conflicts between vehicles making this movement and the ones already using J.P. Road.

Figure 23: Arrow indicating allowed right turning

If the right turning access to the main road is allowed, this intersection should be signal-controlled and the arrow should indicate both right and left turning. Otherwise, the central reserve should be closed and the arrow should indicate left turning instead.

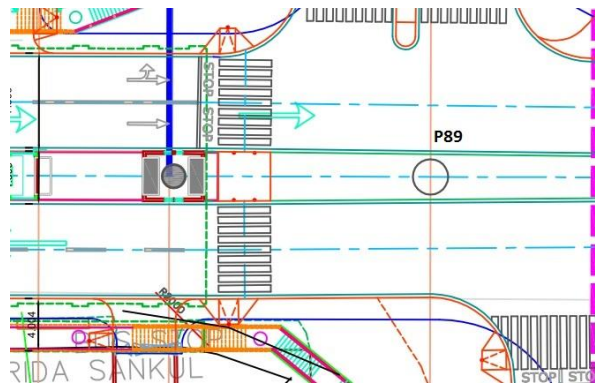
Location: J.P. Road, between P88 and P89

At the second part of the crossing, the sidewalk is too narrow due to the stairs of the metro station. This sidewalk is also too close to a property gate under the stairs, which may obstruct the visibility of vehicles.

Figure 24: Pedestrian crossing in front of narrow sidewalk

The second part of the sidewalk should be staggered to a wider part of the sidewalk (closer to P89).

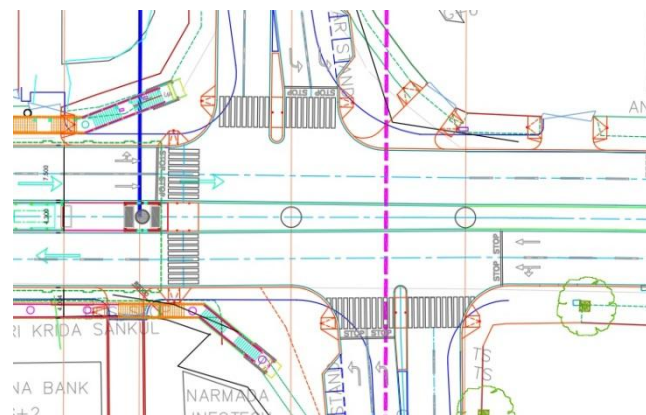
Location: J.P. Road, P89

The markings at the two side roads indicate that vehicles at both lanes should turn left and access the main road. If two vehicles try to access J.P. Road at the same time, they may not have an appropriate visibility of the other vehicles at the main road.

Figure 25: Arrows in side road indicating left turning

If the junction is not signal-controlled, it is recommended to allow only one vehicle at a time to access the main road. This can be done by extending the sidewalks and central islands.

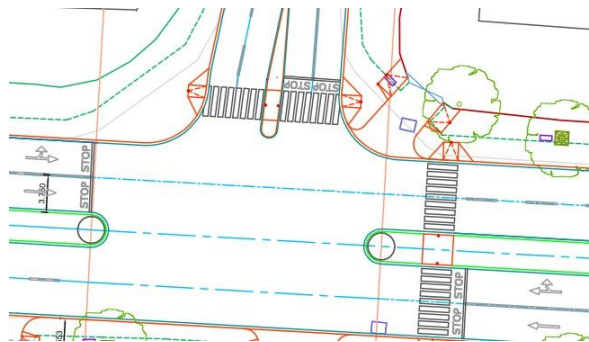
Location: J.P. Road, between P94 and P95

The arrows in the drawing indicate that right turning is allowed from the main road to access the side road. Right turning may create many conflicts between vehicles in different lanes. There are no arrows indicating which movements are allowed to vehicles leaving the side road.

Figure 26: Arrows in main road indicating right turning to access the side road

If right turning is allowed from J.P. Road to access the side road, this intersection should be signal-controlled. Otherwise, the arrow in the main road should be changed to one indicating straight movements and the central reserve on the western side should be extended to the middle of the junction.
